**CRA SHWORTHINESS OF AIRCREW PROTECTIVE ARMOR**

**Aviation Safety Engineering and Research  
Phoenix, Arizona**

TECHNICAL REPORT  
68-57-CM

April 1968

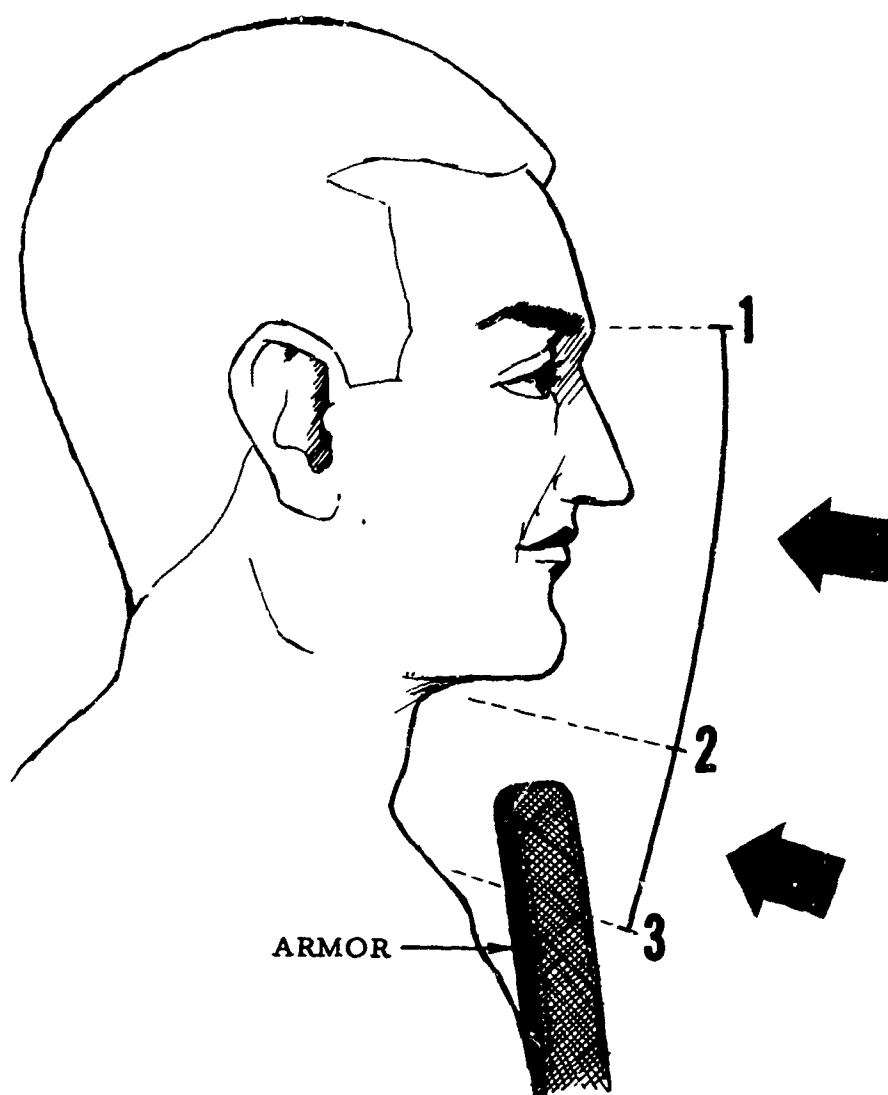
Figure 4. Face/Armor Contact Zones.

Direct contact of the upper edge of the armor with the neck area along the arc from 2 to 3 in Figure 4 could produce serious damage, the most dangerous being fracture of the trachea, especially at the larynx. These are serious injuries, as the vocal cord spasm or collapse of the trachea associated with this trauma may occlude the airway long enough for death to result. The forces measured at the top of the armor were

more than sufficient to cause this trauma<sup>(4)</sup>. In the test program, direct contact of the armor with the neck area occurred in only one test compared with 19 impacts to the face area in the remaining 29 tests (see Tables I and II for details). However, caution should be exercised in using these figures from which to draw the conclusion that the possibility of neck impact is low. It was recognized during the early planning that the neck area simulation of the anthropomorphic dummy was very poor. Several agencies visited are presently engaged in projects to increase the level of simulation; however, the improvements were not available for incorporation into this test program. What is significant here is the fact that sufficient force was recorded at the top of the armor to cause serious injury to the throat area. A practical modification of the armor-vest-carrier to avoid this occurrence would be to pad the neck area in some fashion. An energy-absorbing, fragment-deflecting, turtle-neck unit (Figure 5) would satisfy this requirement.

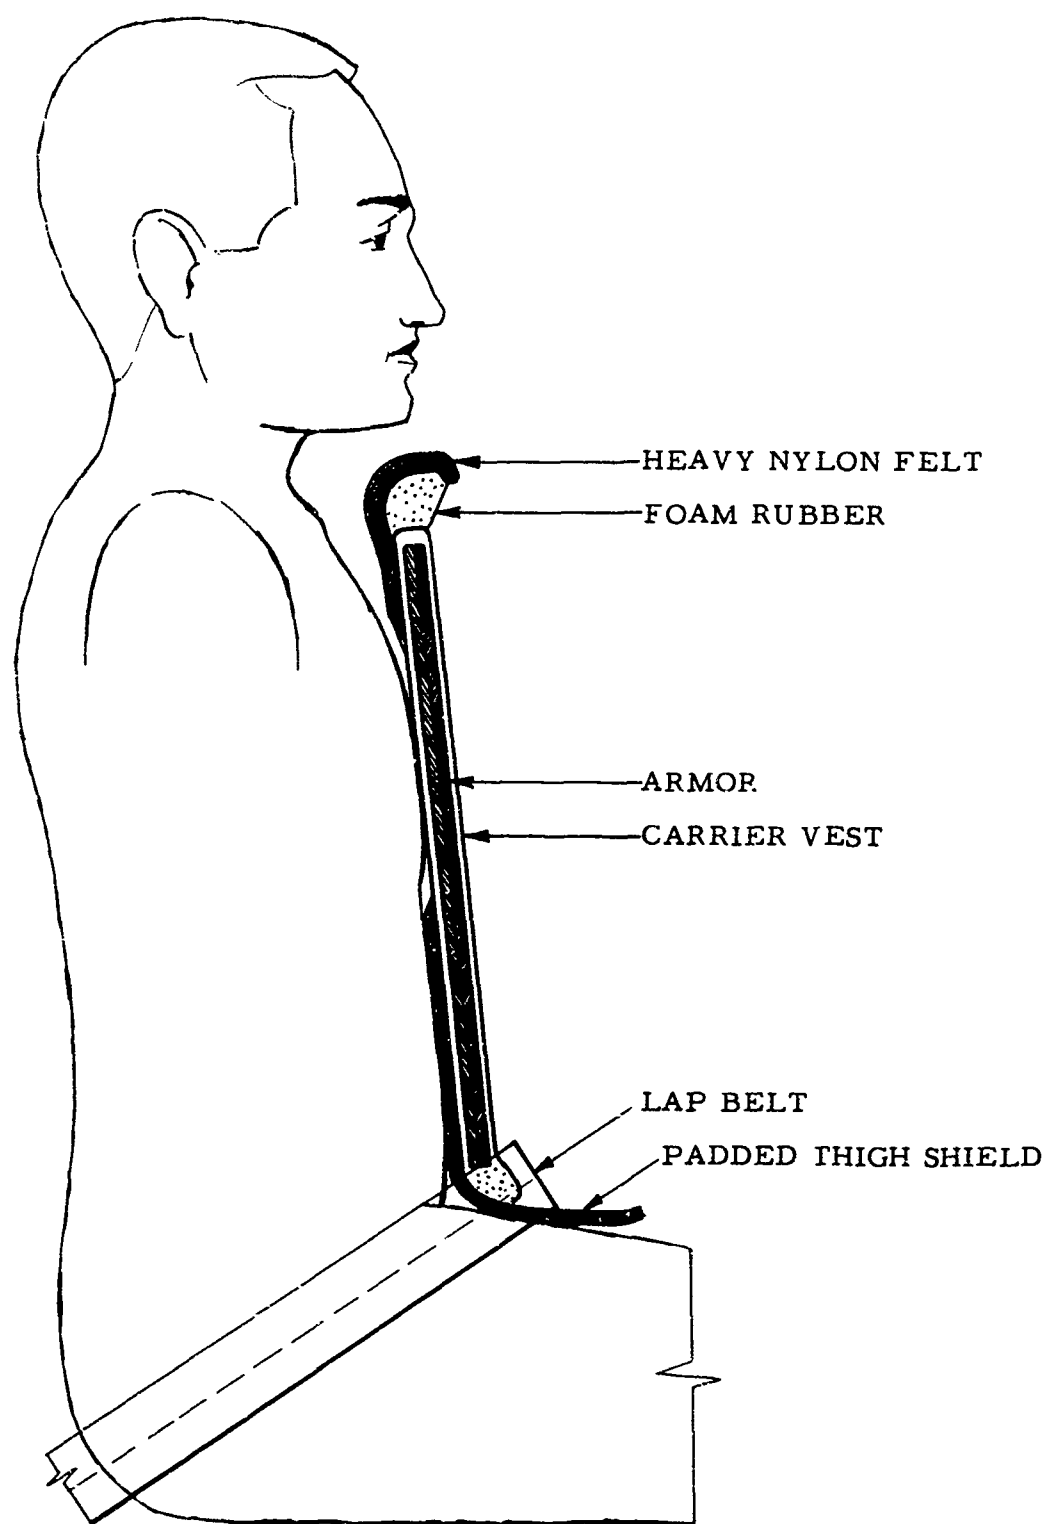
Figure 5. Recommended Padding for Upper and Lower Edge of Armor.

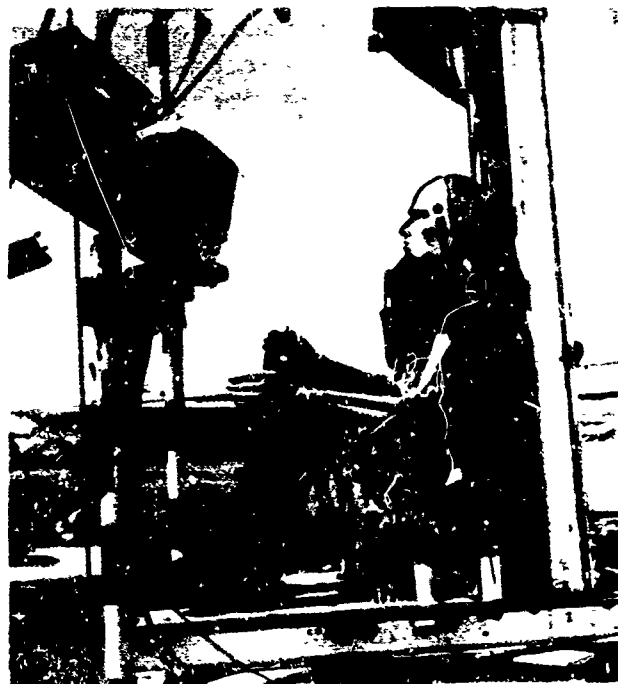
Figure 44. Posttest Position of Armored Dummy in Test 20.  
(Note position of lap belt at midline of chest armor.)

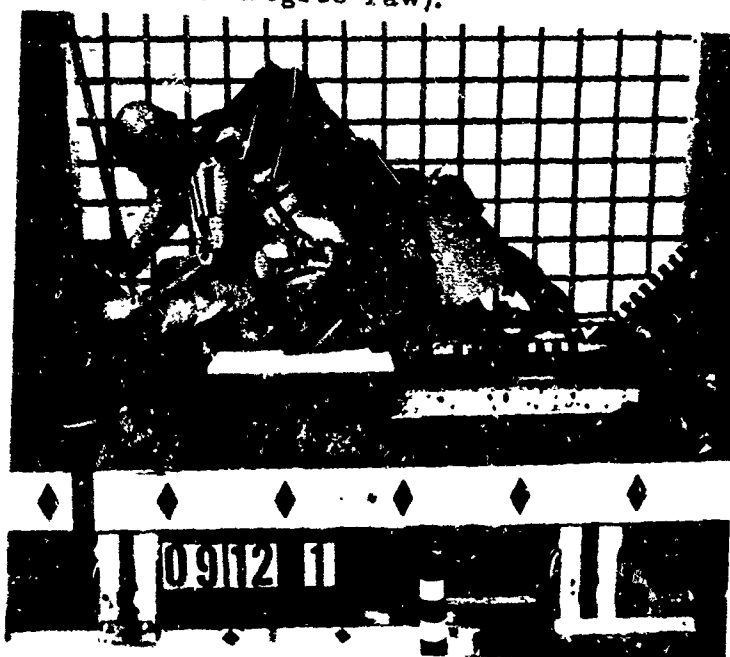
Figure 52. CH-47 Seat Failure, Test 1.

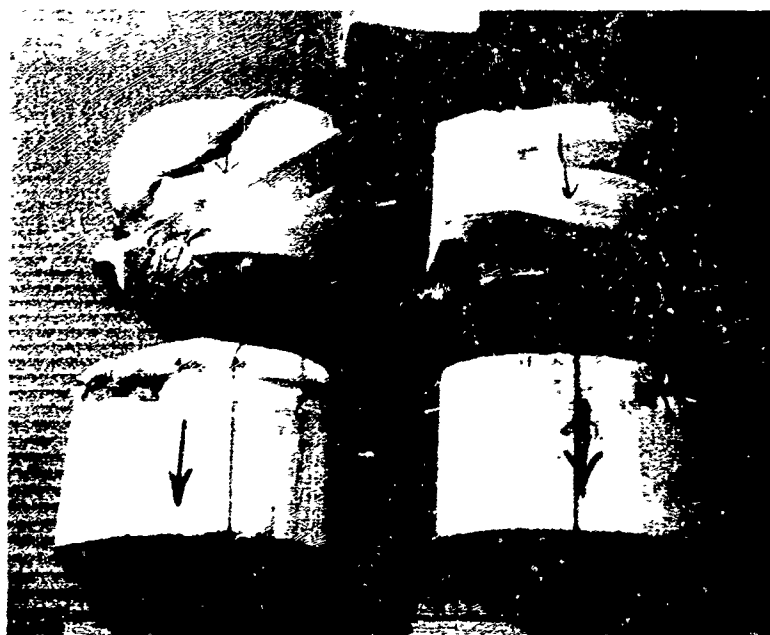
In this series of tests, the thigh pads suffered heavy damage, especially those involving the chest armor. Examination of the thigh pads showed that the damage consisted primarily of shearing failure of the styrofoam caused by the lap belt. Close examination of the pad did not reveal any damage which might have been caused by the armor. The increased damage in the tests involving chest armor was due to the fact that when the armor is worn, the lap belt is farther forward and comes in contact with more of the thigh pad. Figure 56 shows a posttest view of a typical set of pads.

Figure 56. Styrofoam Load Pads. Posttest View Showing Shearing Failure Caused by Lap Belt.
